UI Bulletin #172c

Subject: Mid-Size Pickup Box Removal / FMVSS/Component Information Resource

Models Affected: Chevrolet Colorado/GMC Canyon 2WD Extended Cab – 36.2" CA `Short Box'

Models Years 2017 - 2022

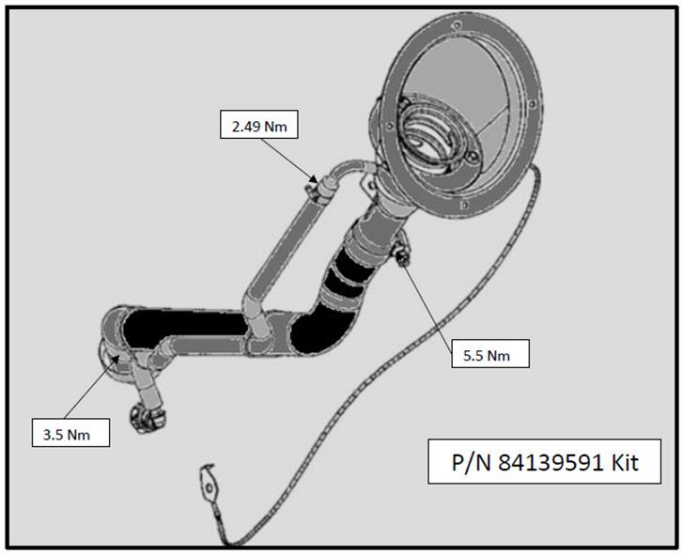
84139591 Gas-Filler Assembly, 23361879 Cap (RPO-BJA),

Colorado / Canyon models approved for `Pickup Box Removal’ require refitting the vehicle with the approved RPO-ZW9 Capped Fuel Fill Assembly Components. Care must be taken to follow GM UI BBM Fuel Fill Installation & Positioning Guidelines and when installing upfit bodies on the chassis. Upfitters should use the following combination of approved RPO- ZW9 Fuel Filler Components for completing `Pickup Box Removal’ upfit applications.

Refer to GM UI BEST PRACTICES `CHASSIS’ Section regarding routing & serviceability and securing hose assembly. http://www.gmupfitter.com
